HISTORIC AMERICAN BUILDINGS SURVEY
INVENTORY

2. NAME *Orrin Thompson Mansion*

DATE OR PERIOD *1832*
STYLE *Greek Revival*
ARCHITECT
BUILDER *Orrin Thompson*

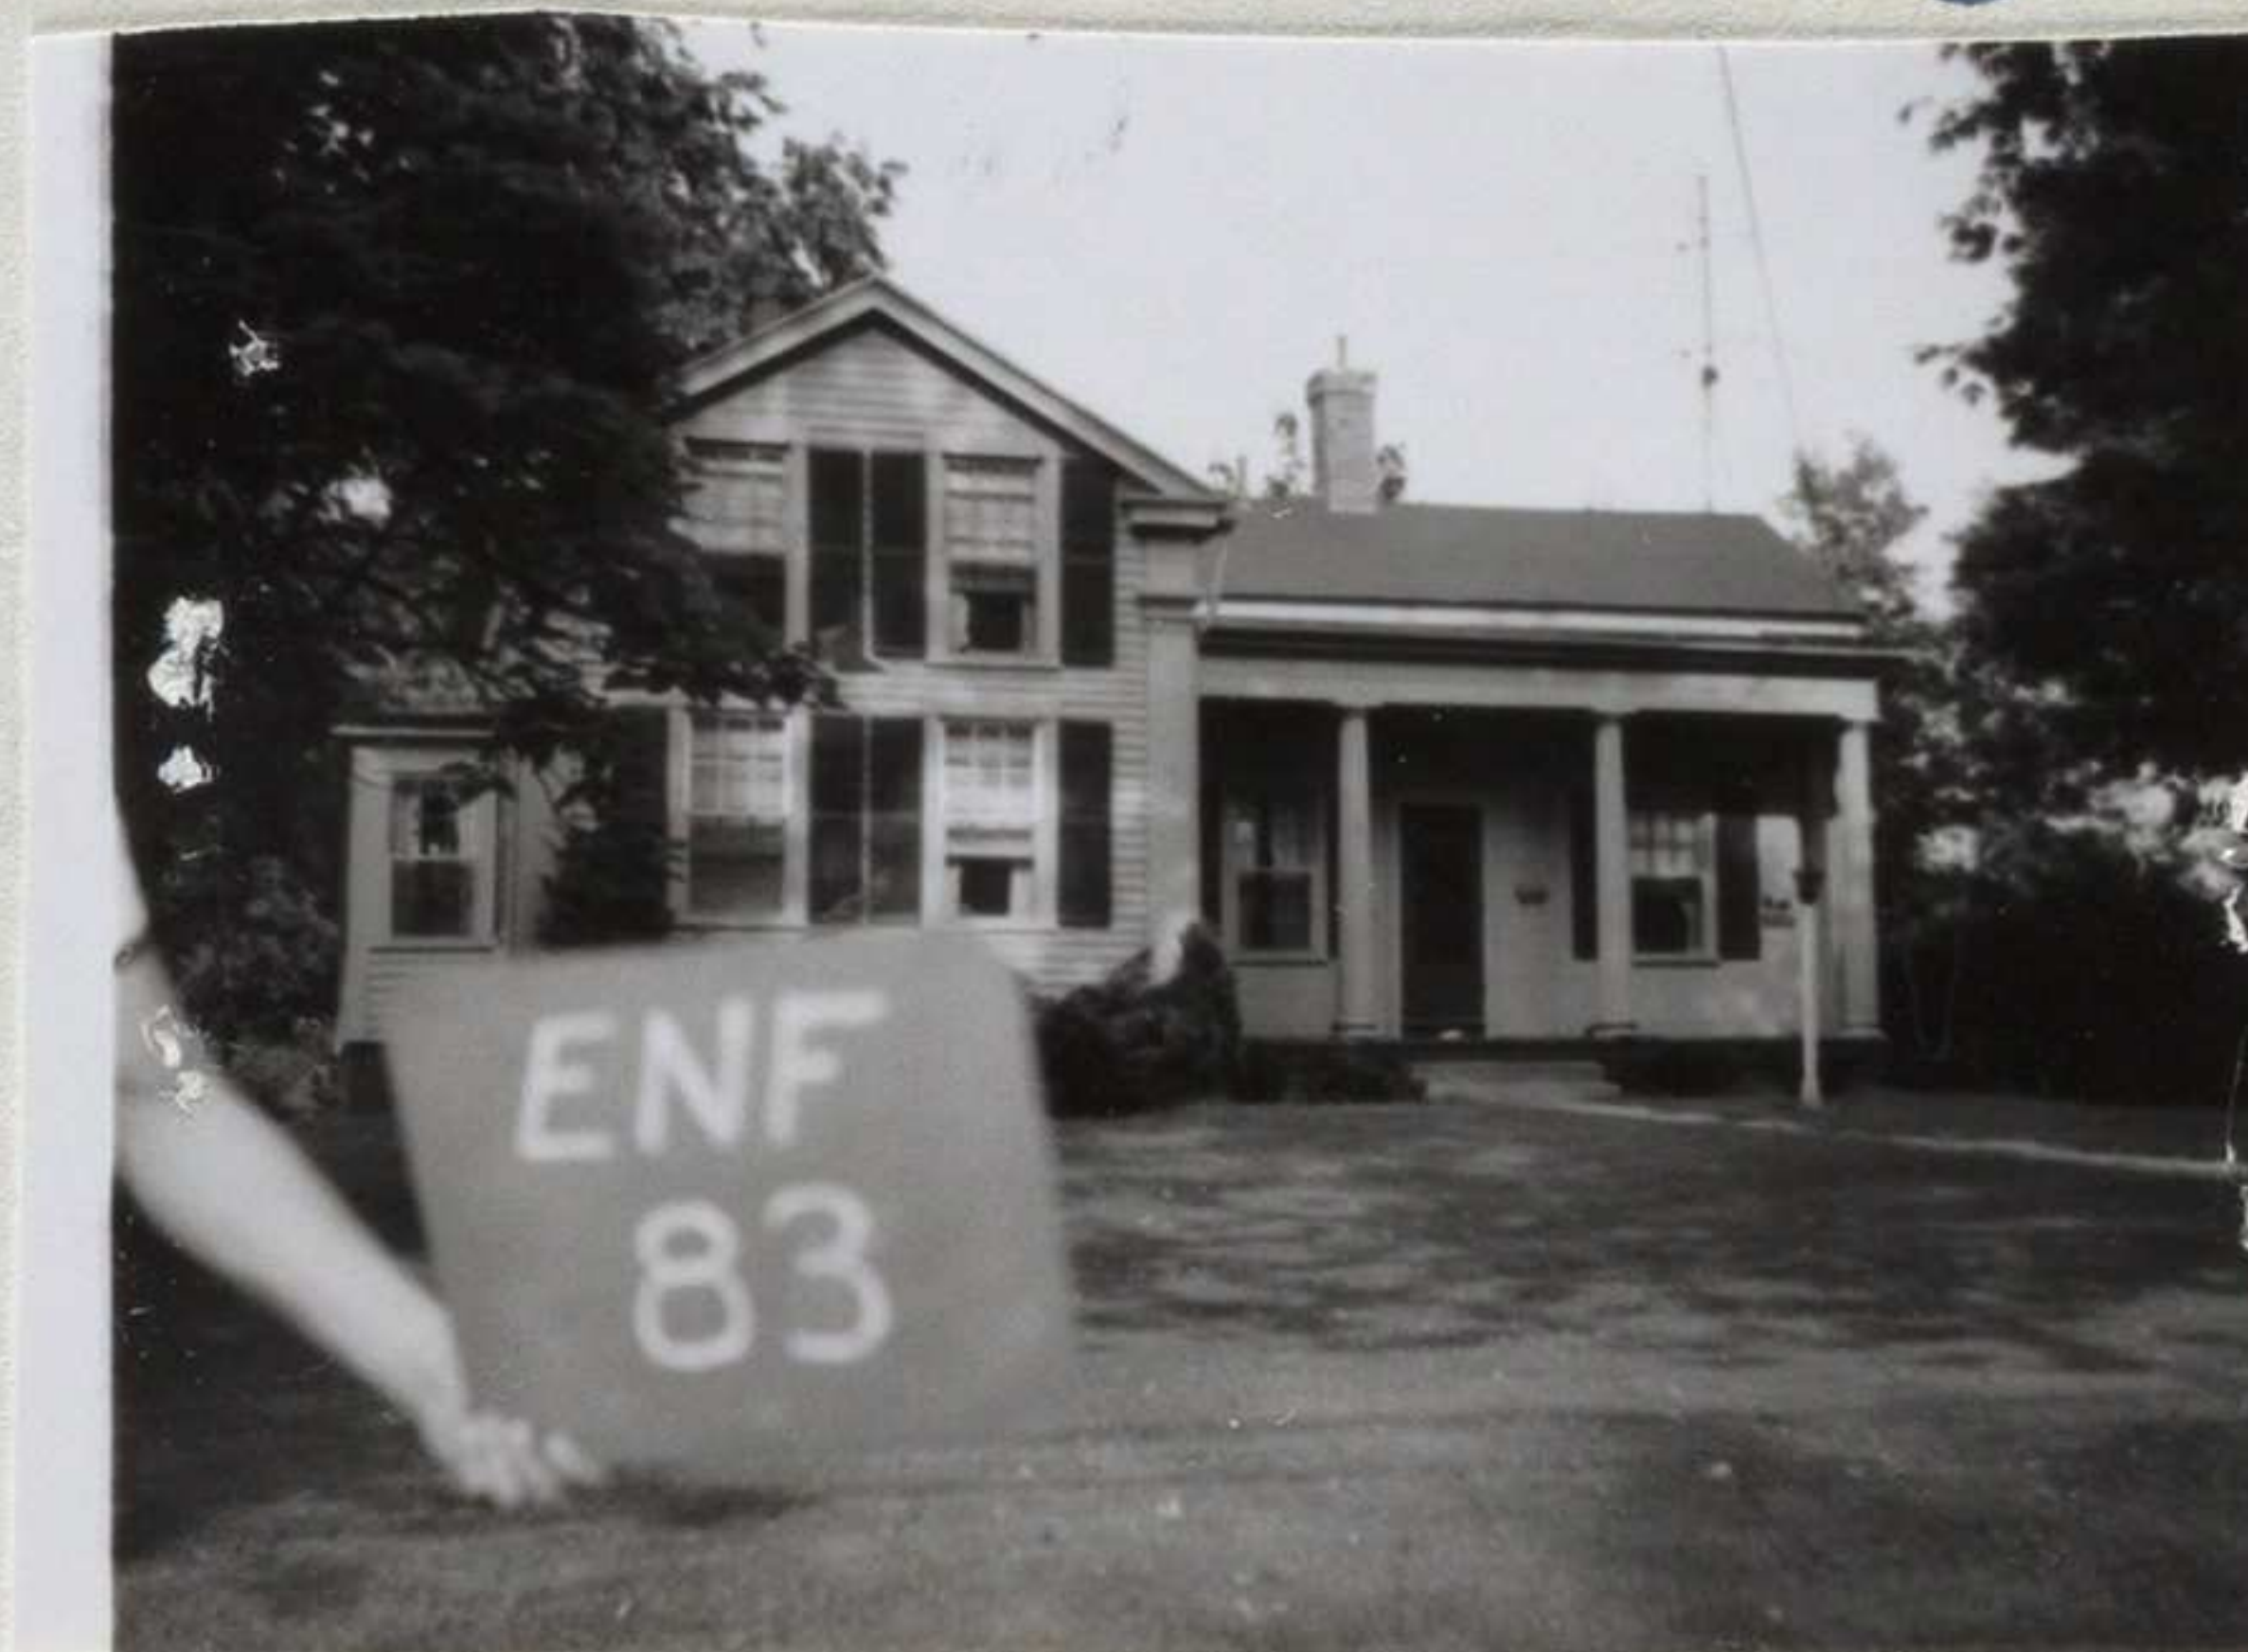
7. PHOTOGRAPH *Enf 83*

Built on a brick foundation this ell shaped house has a shallow pitched roof. The main feature of the house is a Doric colonnade setting off the South wing. The wall behind this section is plain boarded. The corners of the house have plain Doric pilasters supporting a heavy entablature. The shuttered windows are 6/6's.

Exterior *good*

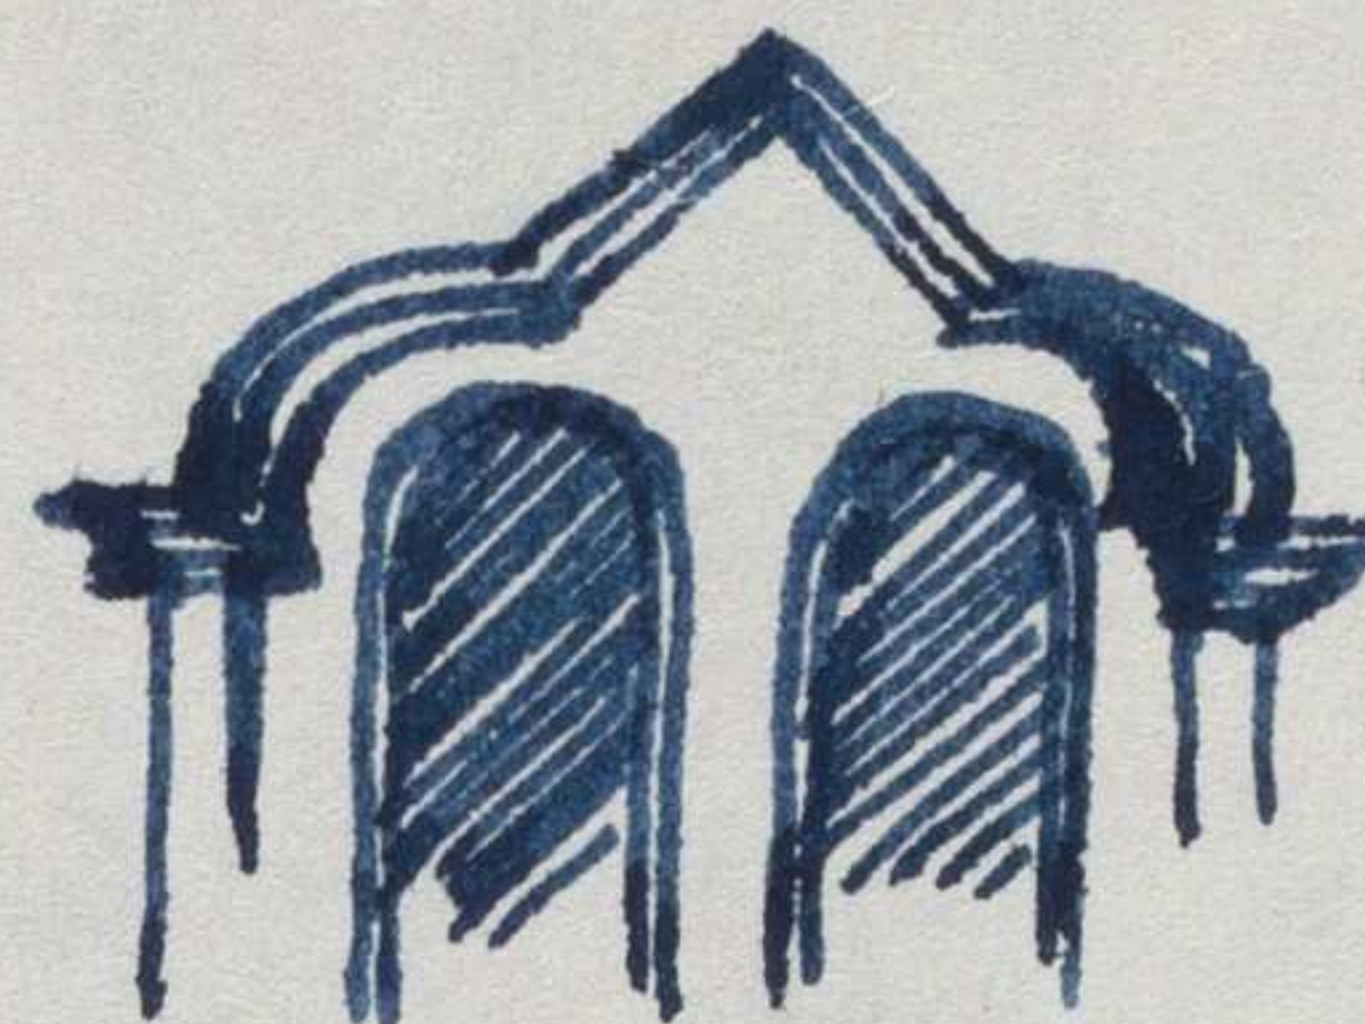
dormer window

The rear section of this house may well have been built earlier but the basic fabric of the place is high Victorian. The house is built on a brick foundation. The central tower whose picture we viewed in a local architect's office is now removed, as is the doorway once located in its base. Bay windows occur on the front and south sides. The fine dormers also exist above well turned brackets.

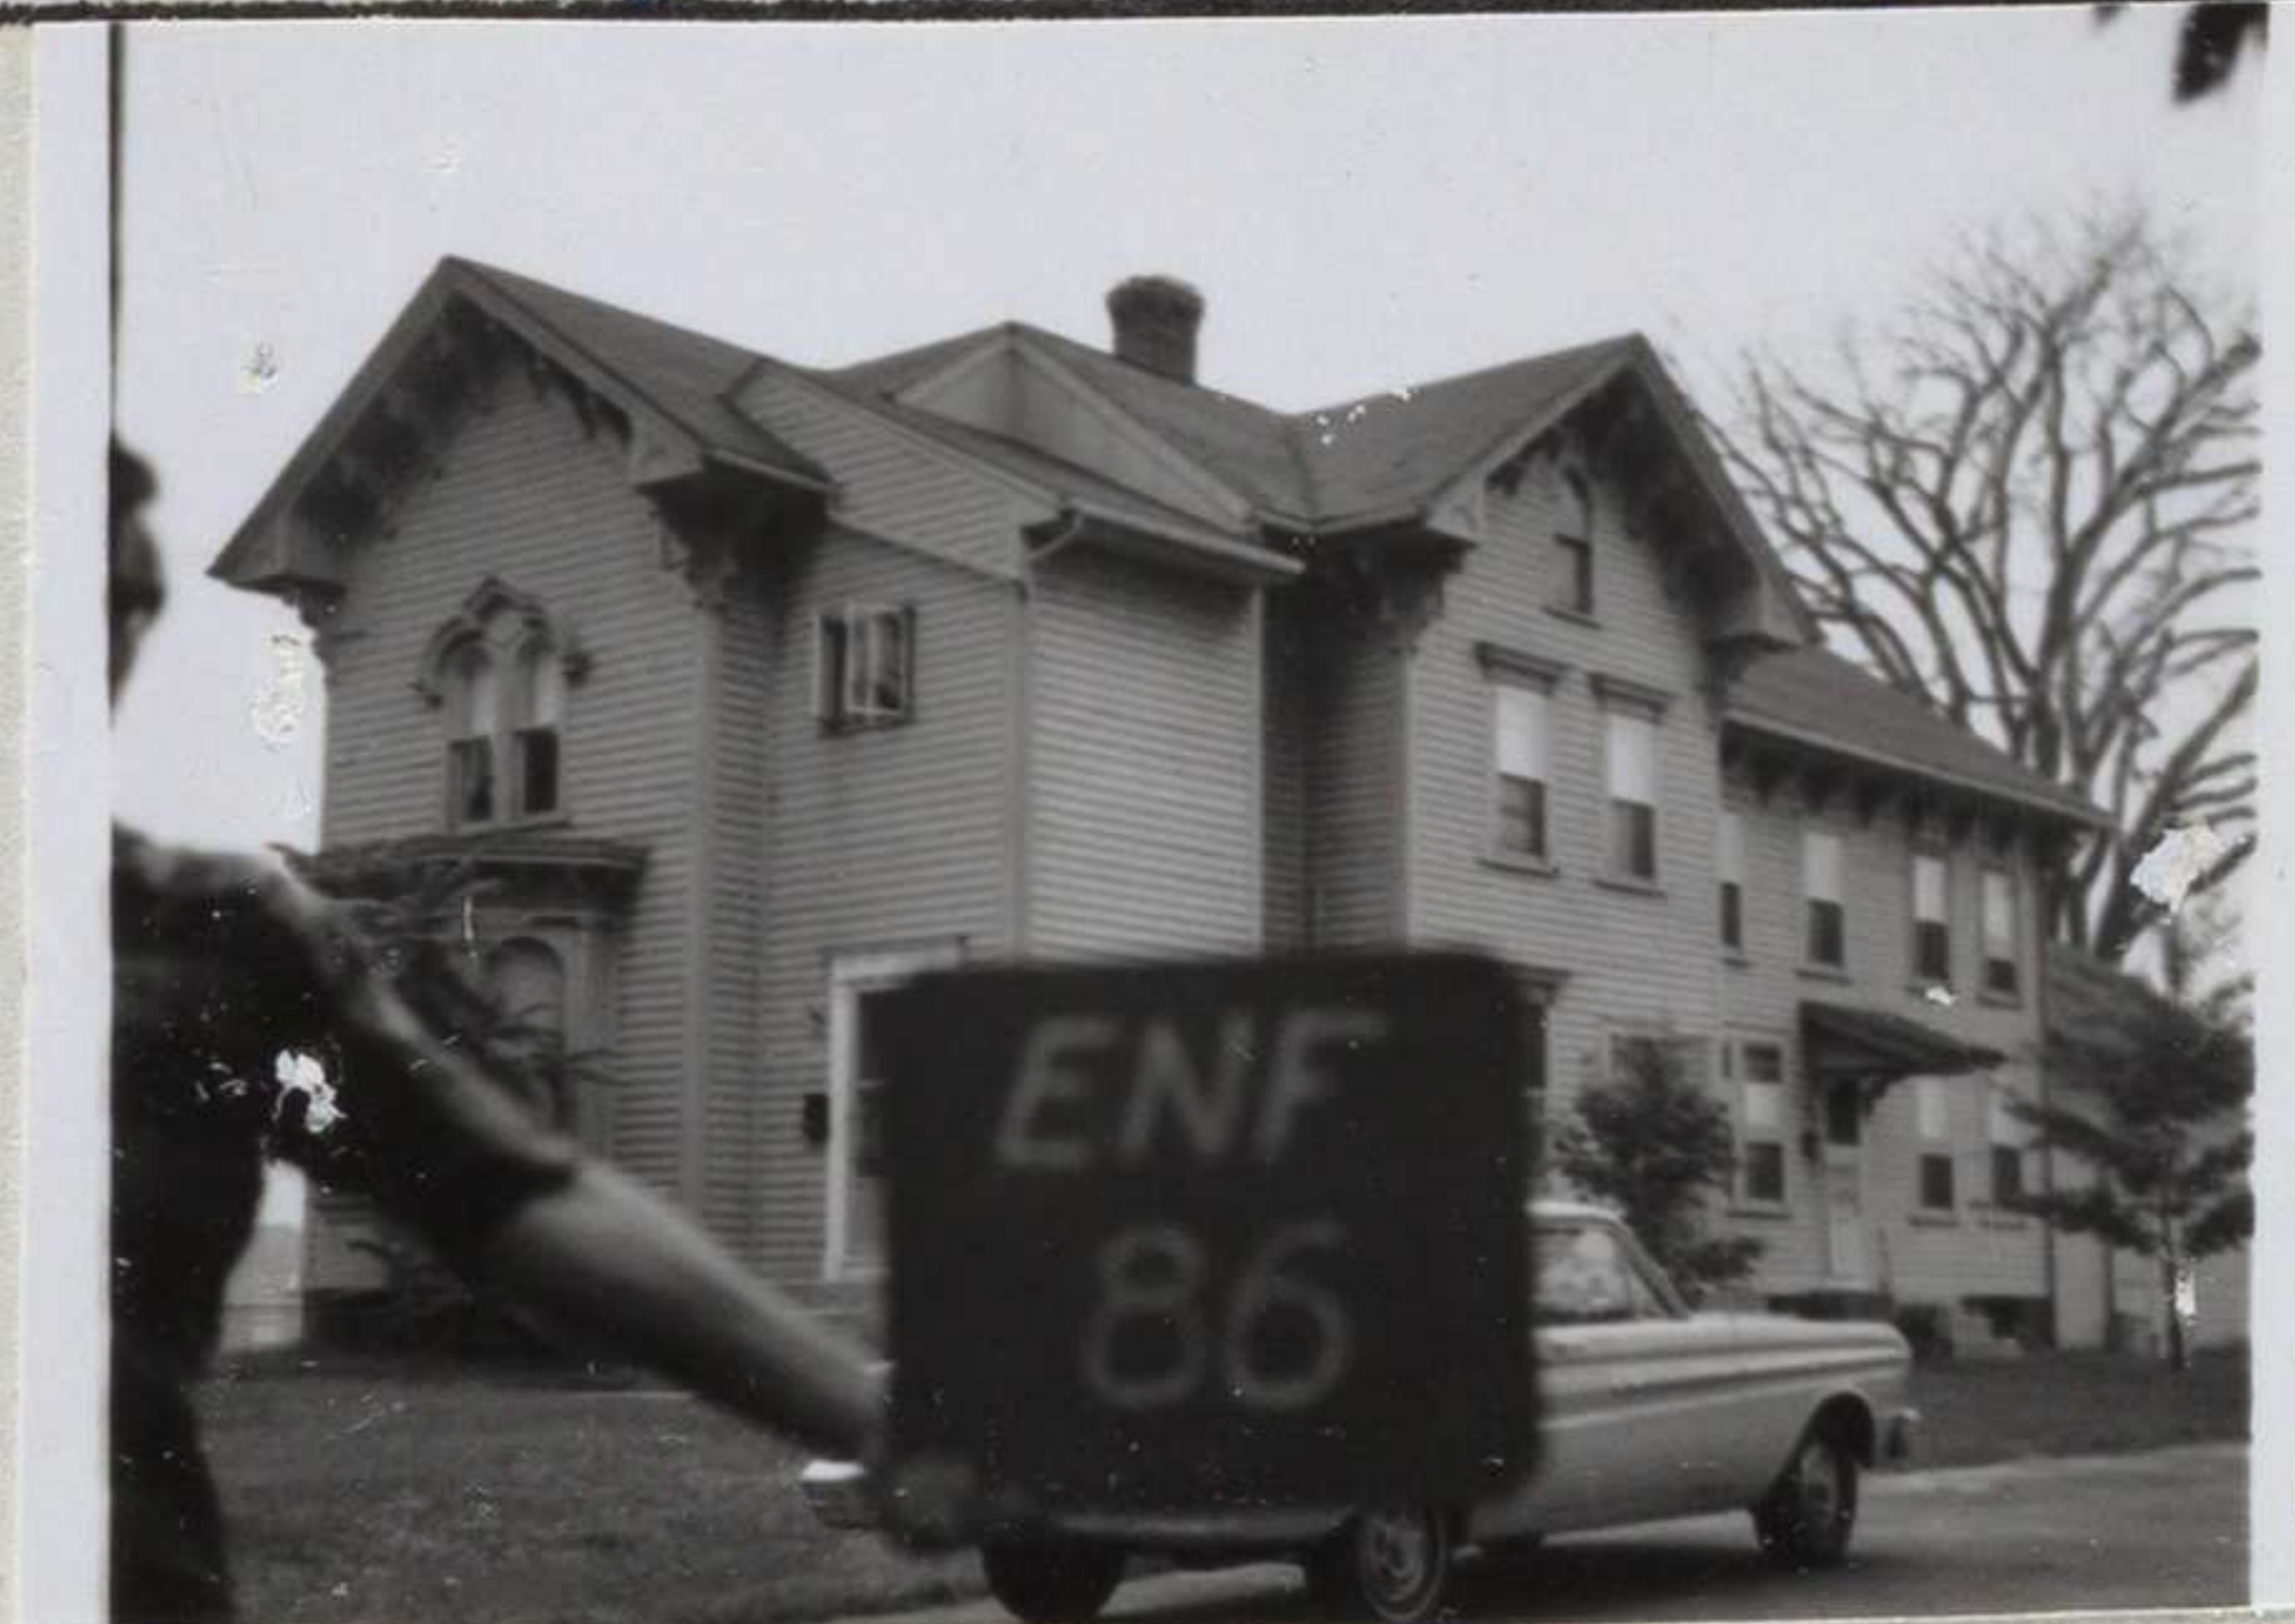
7. PHOTOGRAPH *Enf 86*

Endangered ? Interior *poor* Exterior *poor*

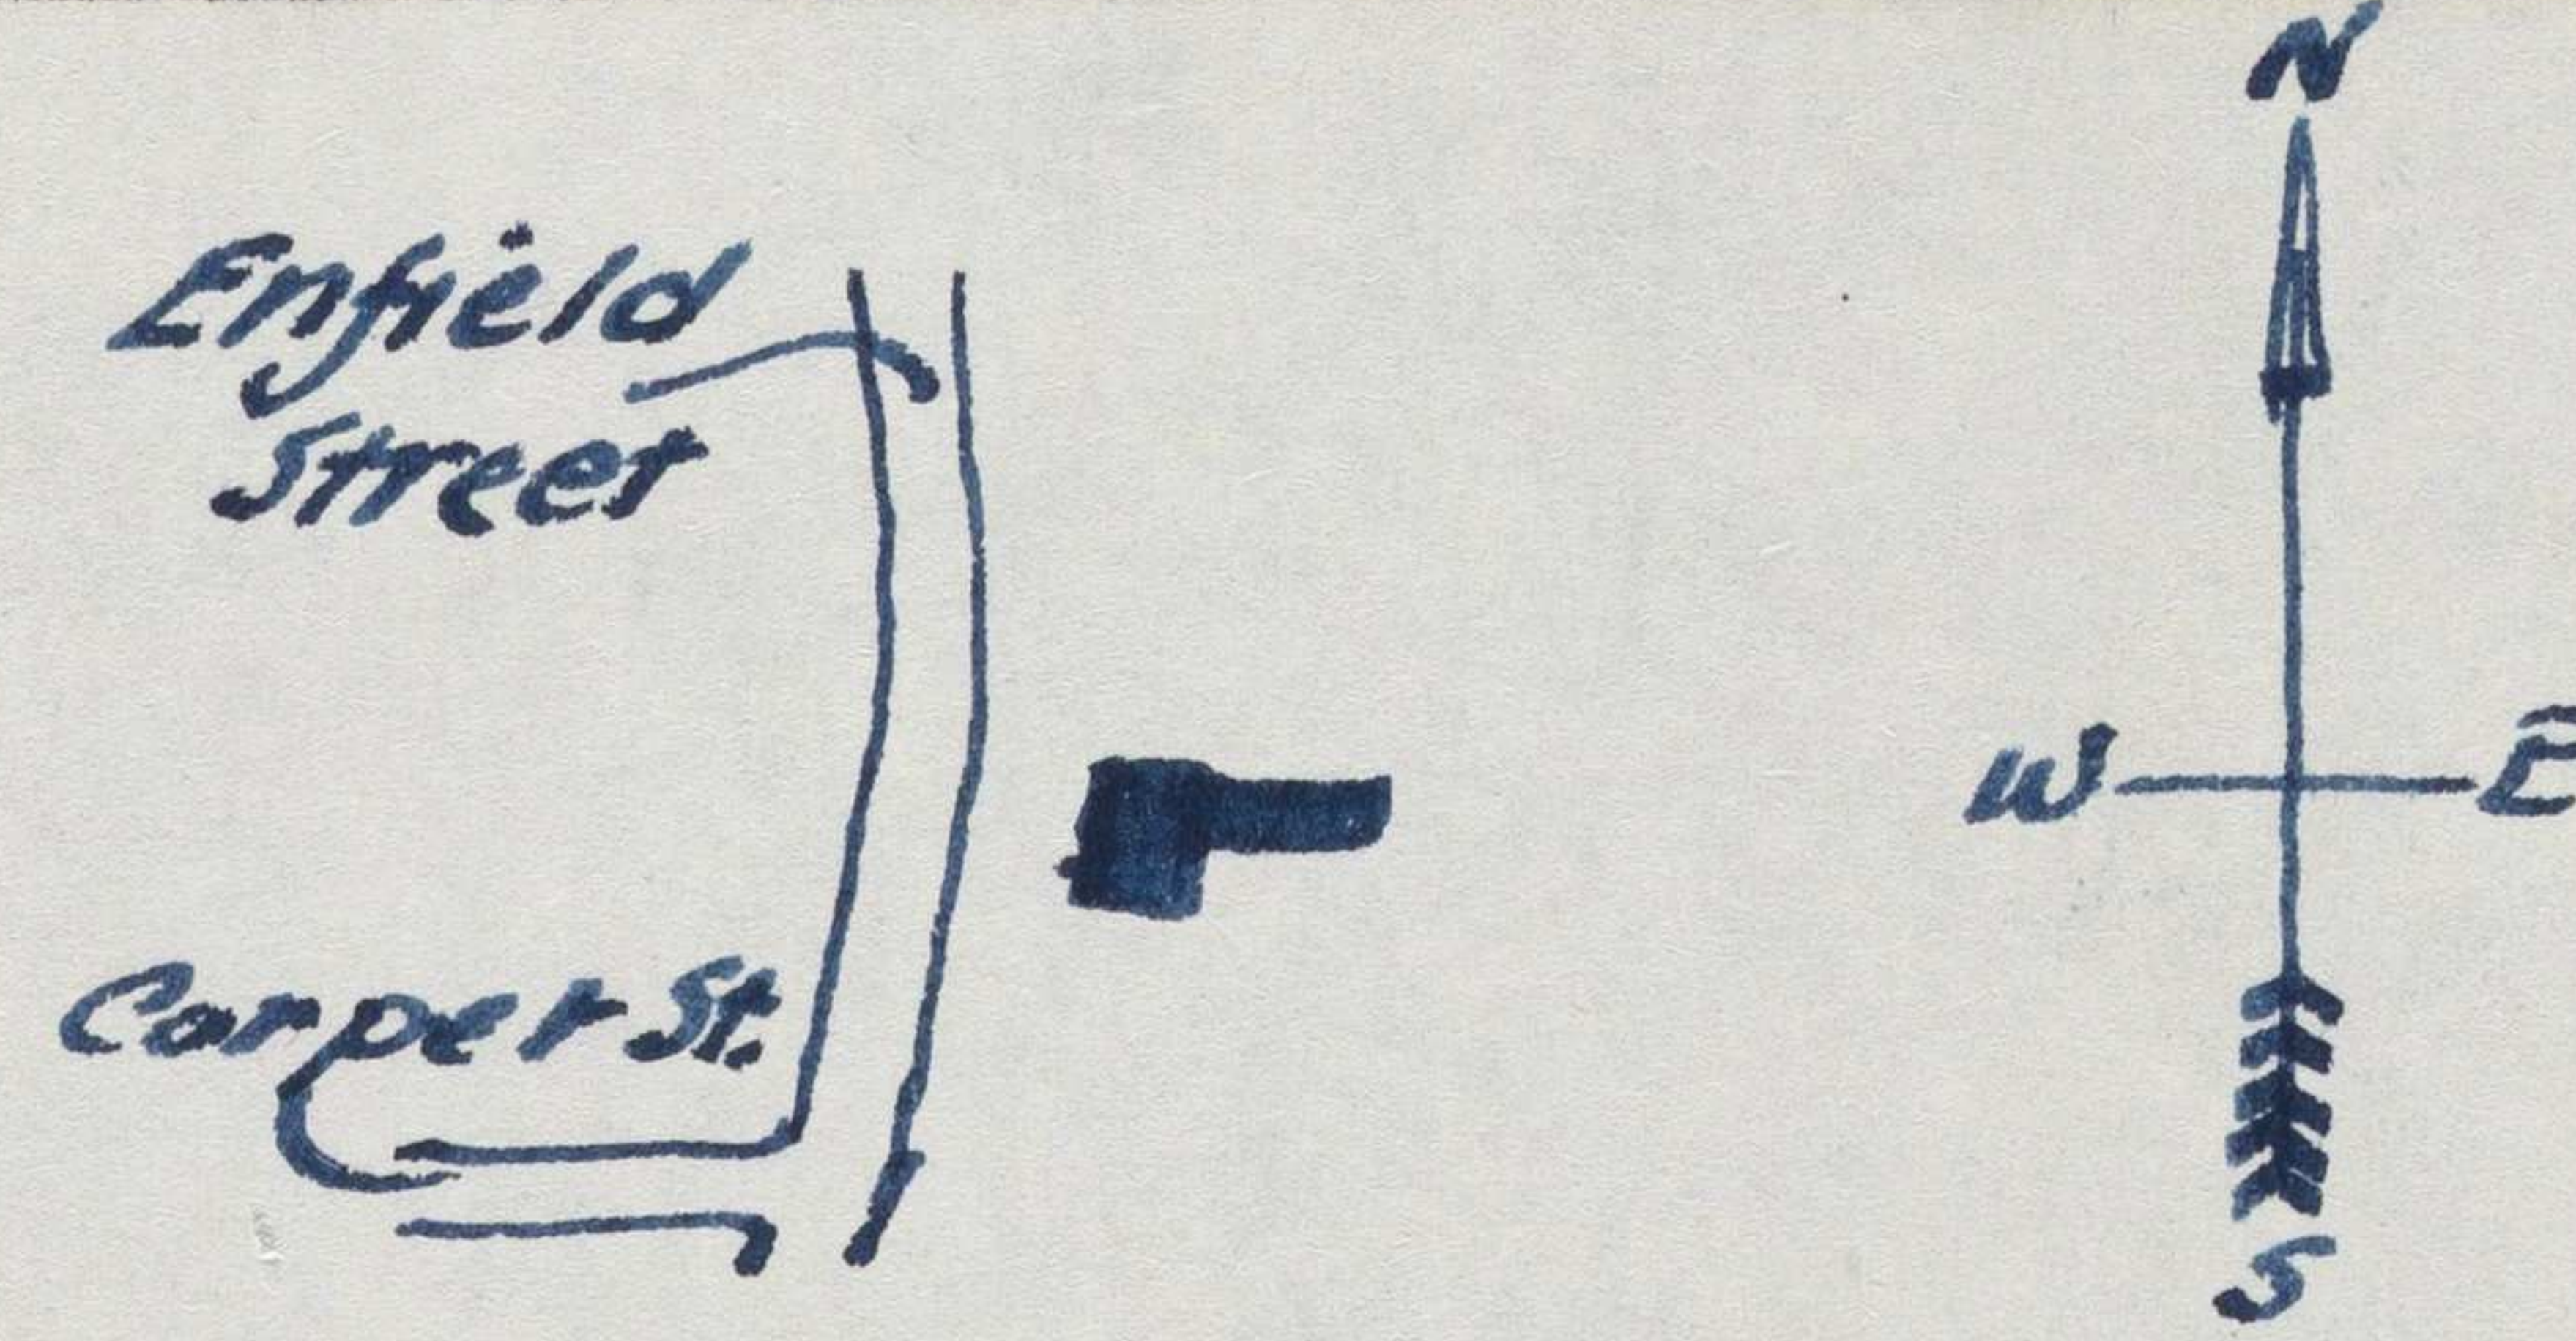
7. PHOTOGRAPH <i>Enf 88</i>

4. NOTABLE FEATURES, HISTORICAL SIGNIFICANCE AND DESCRIPTION	OPEN TO PUBLIC <i>No</i>
<i>This house has been largely changed. Atop a brownstone foundation, the 5 bay house is now shielded by a porch. The doorway has been projected out some 2 feet; the windows are 6/6's. Two end chimneys cap the medium pitched roof.</i>

5. PHYSICAL CONDITION OF STRUCTURE	Endangered <i>?</i> Interior <i>poor</i> Exterior <i>poor</i>
------------------------------------	---

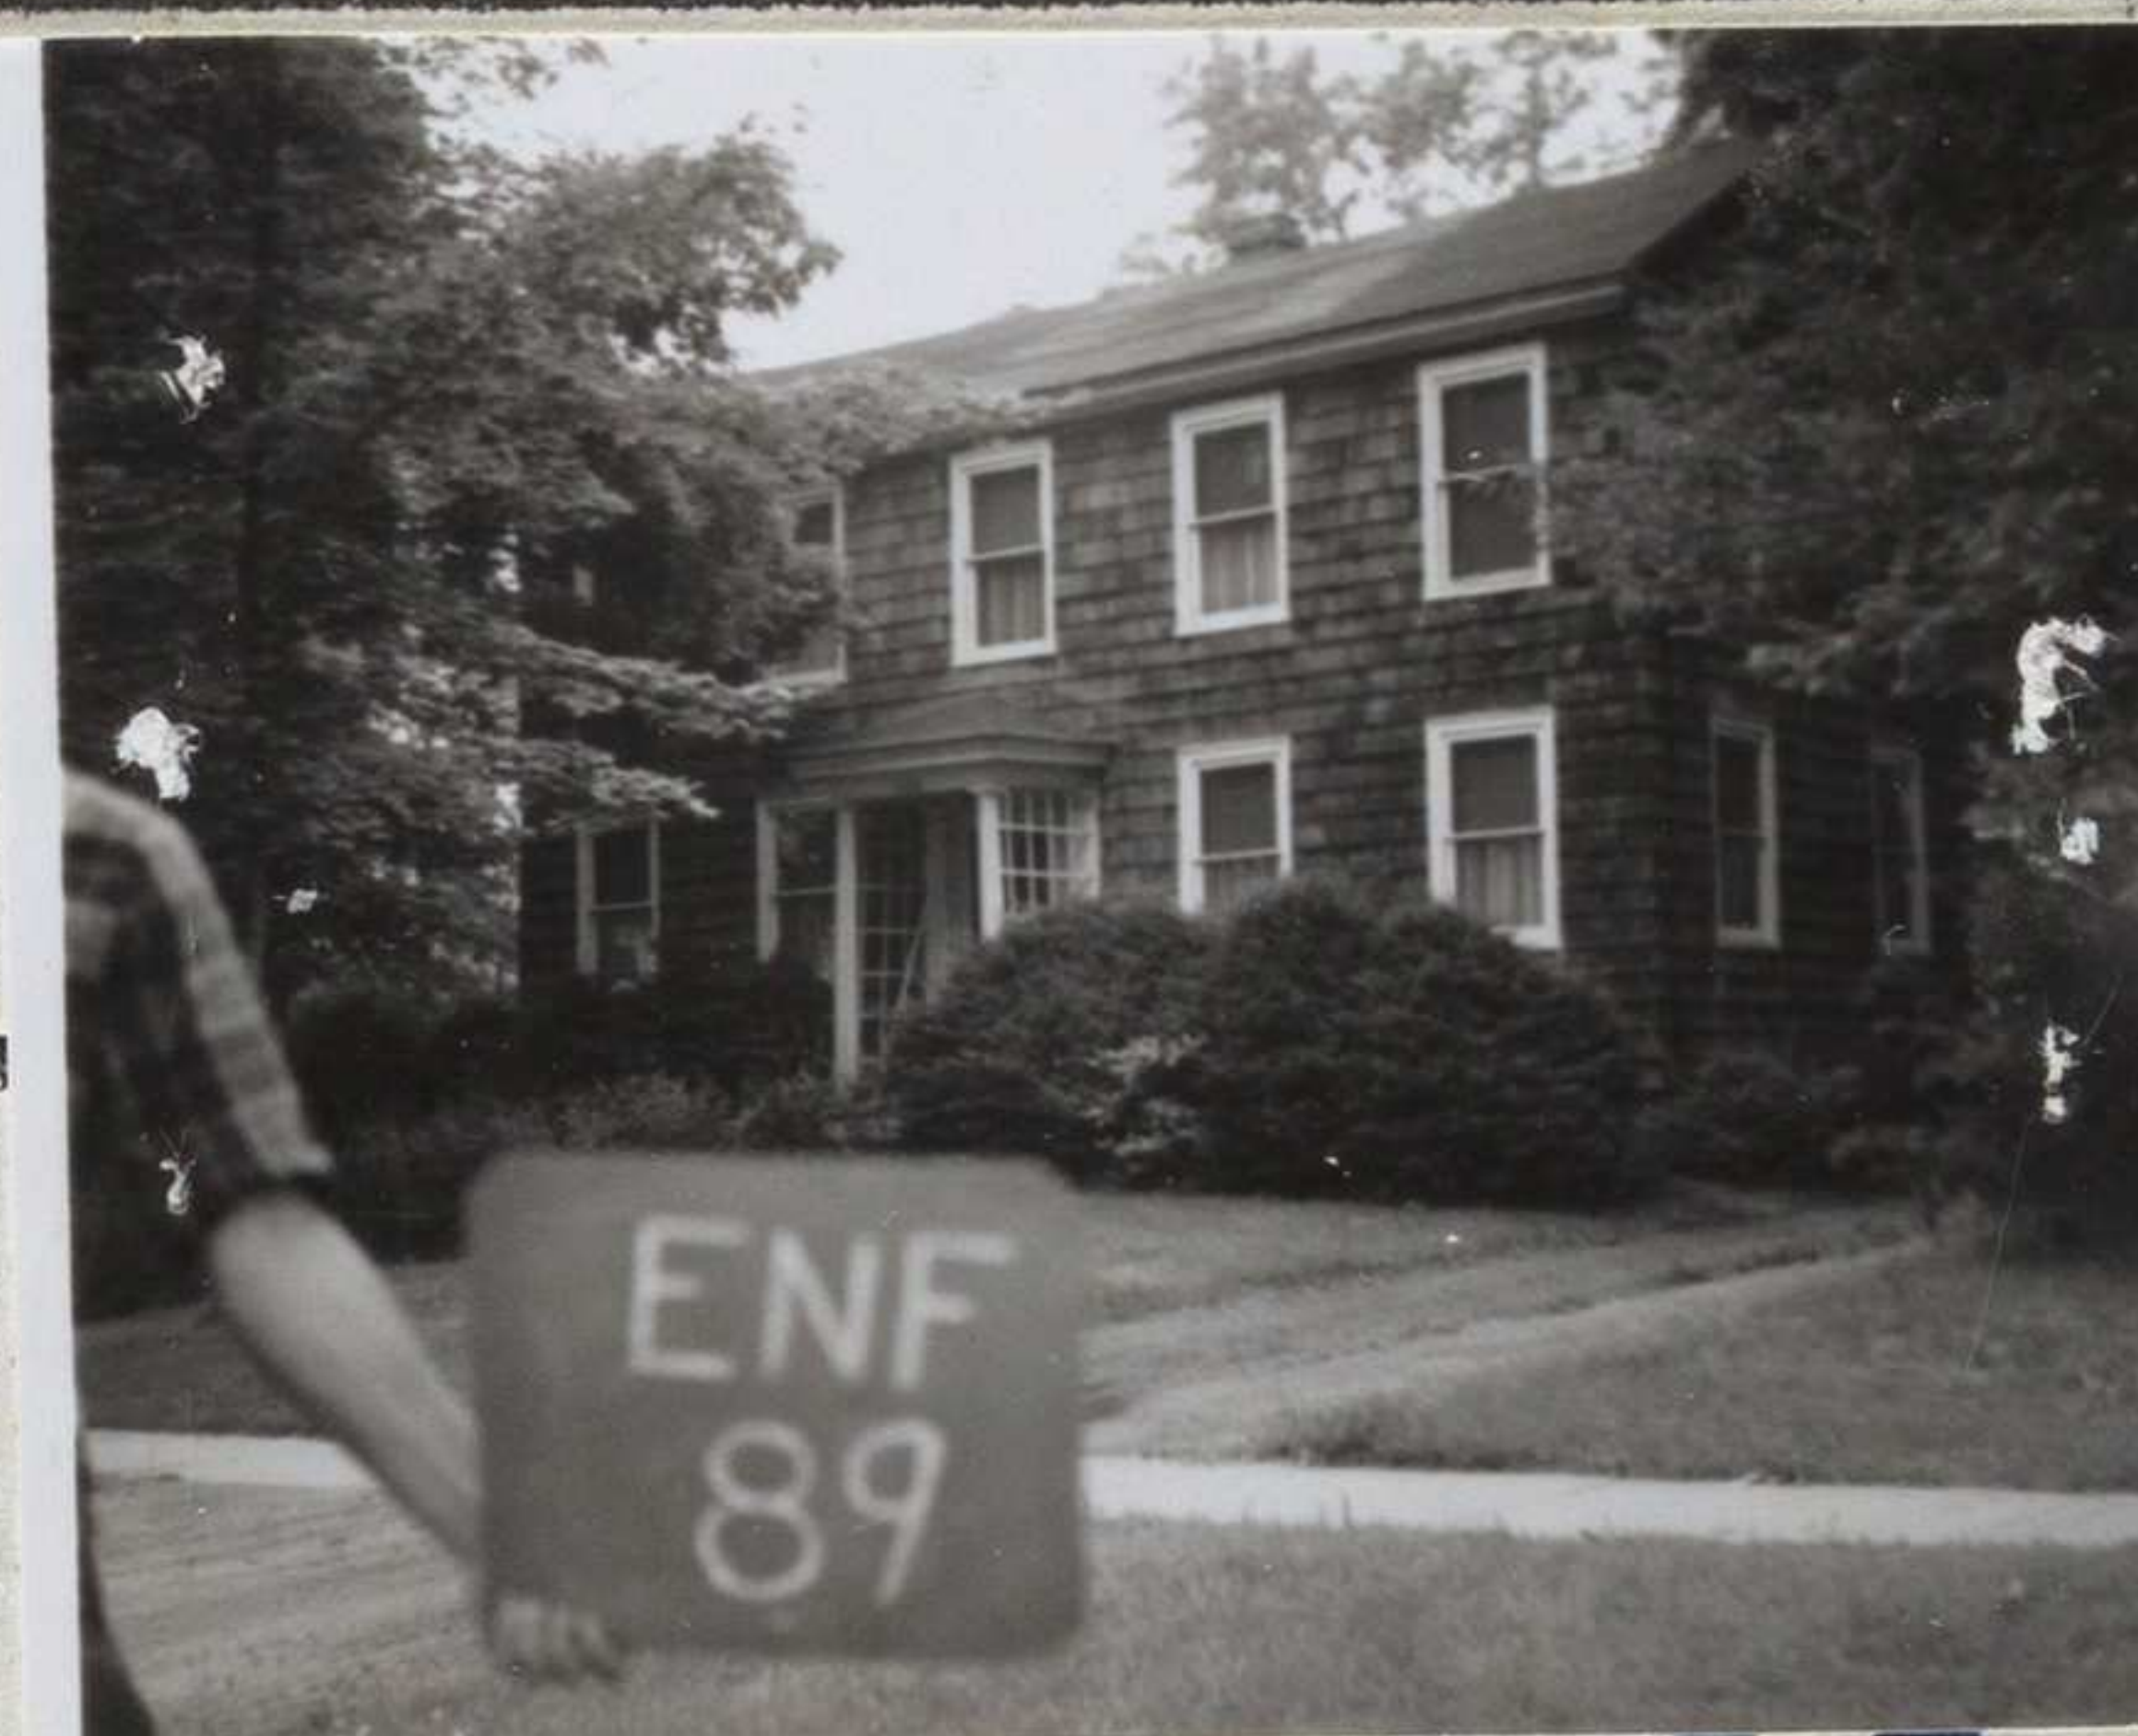
7. PHOTOGRAPH *Enf 89*

The foundation of this house is mostly brick, brownstone making up the facade supporting wall. There are five bays to this house of little depth. A non-original chimney surmounts the roof of medium pitch. The doors, windows, roof and wall covering are also new.

Endangered *No* Interior *Poor* Exterior *Poor*

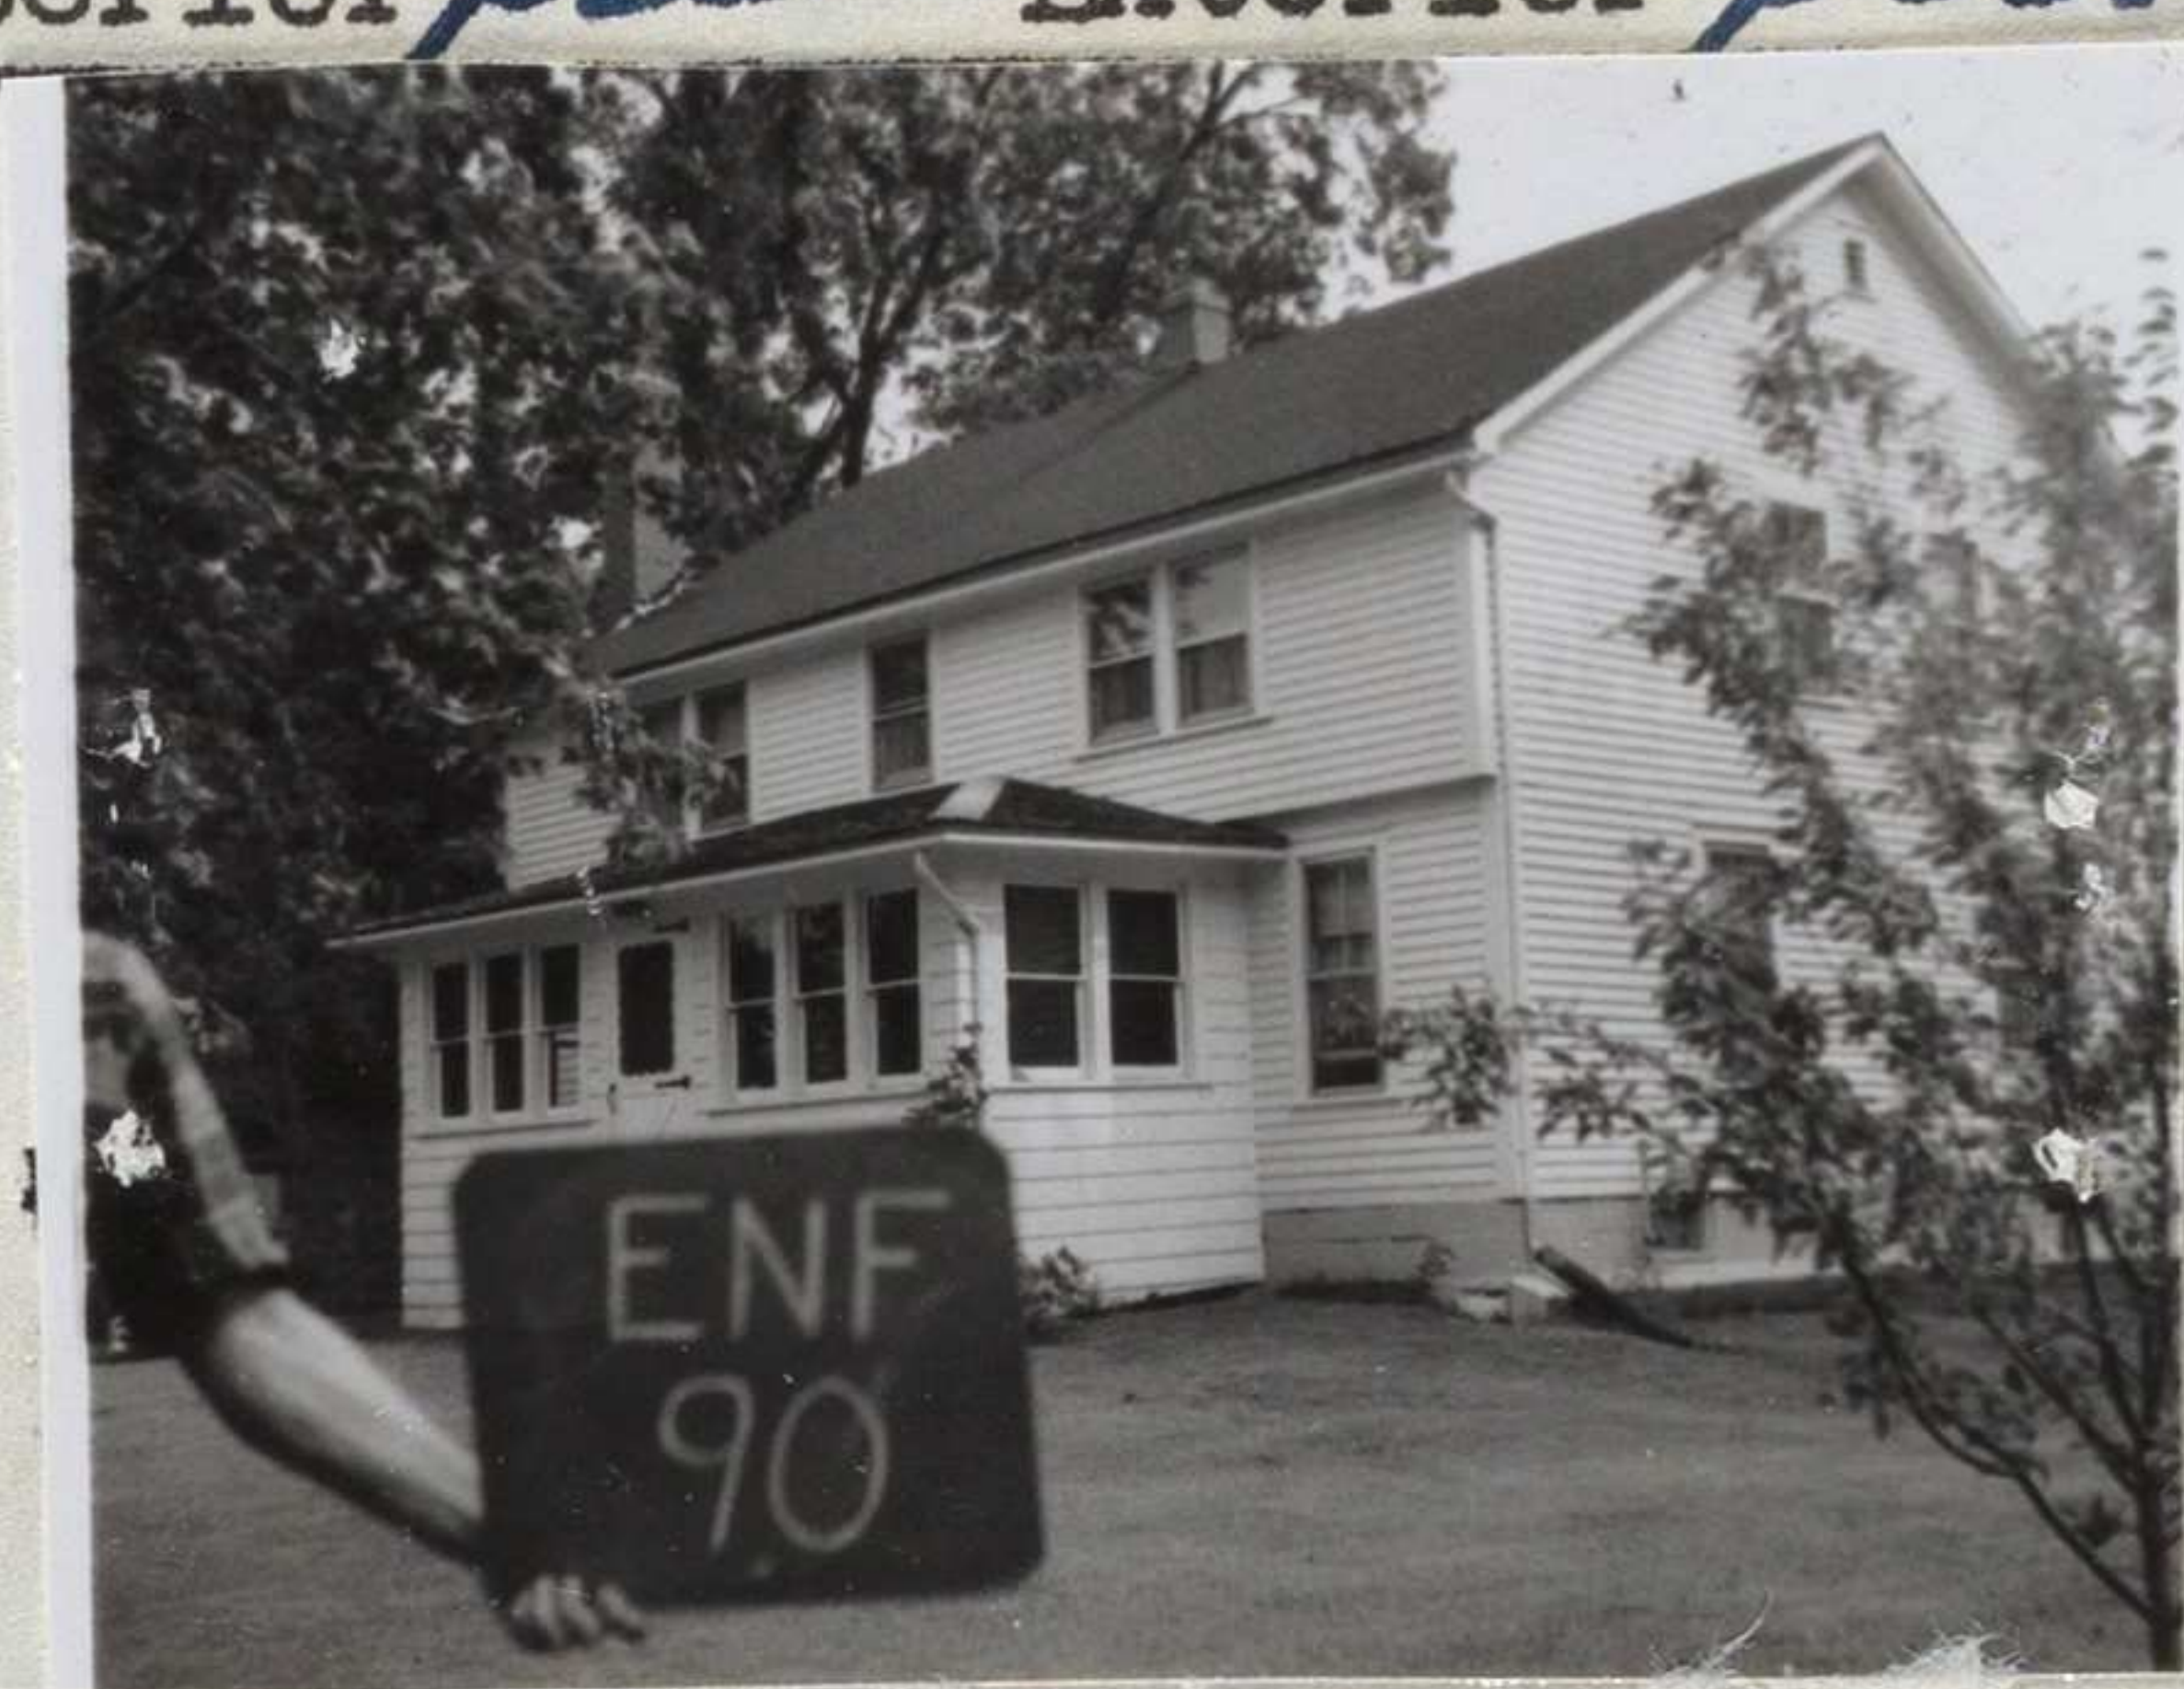
6. LOCATION MAP (Plan Optional)	7. PHOTOGRAPH <i>Enf 90</i>

4. NOTABLE FEATURES, HISTORICAL SIGNIFICANCE AND DESCRIPTION	OPEN TO PUBLIC <i>No</i>
<i>This house has unfortunately little left of its original fabric. There is still left the brown-stone foundation, the medium pitched roof and the projections of the second floor at both front and back. There were originally five bays but no ^{longer} more. Added are the windows and their placement, an east side and new central chimneys, doors and enclosed front porch.</i>	
5. PHYSICAL CONDITION OF STRUCTURE	Endangered <i>?</i> Interior <i>poor</i> Exterior <i>poor</i>
